An Evaluation of IDOT's Current Underdrain Systems

**Physical Research Report No. 120
December 1995**

Illinois Department of Transportation
Bureau of Materials and Physical Research

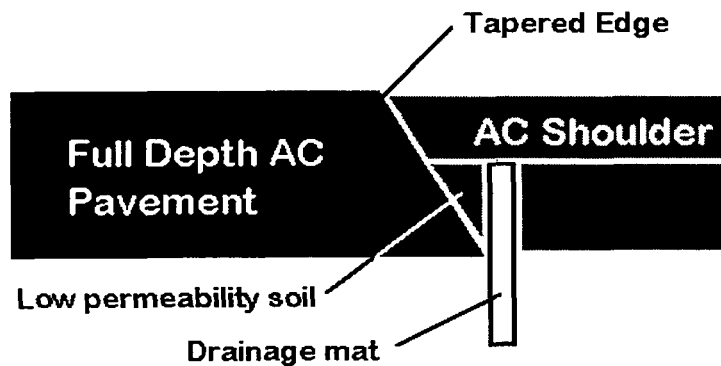
Five of the six 14" mat underdrain samples were eight inches or more from the pavement edge. These drains were only used on full depth asphalt pavement. The wide drain placement was attributed to the trapezoidal shape of the pavement which narrows from bottom to top. In other words, the drain may have been in contact at the base of the pavement, but the tapering of the edge resulted in the top being 8-18 inches away. A major downside of this detail is that it was common for low permeability material to be backfilled in the triangular-shaped area adjacent to the 14" mat underdrain (see figure 4). No sagging or depth control problems were noted for the 14" mat underdrains.

Figure 4. Observed 14" mat installation adjacent to full depth asphalt pavement.

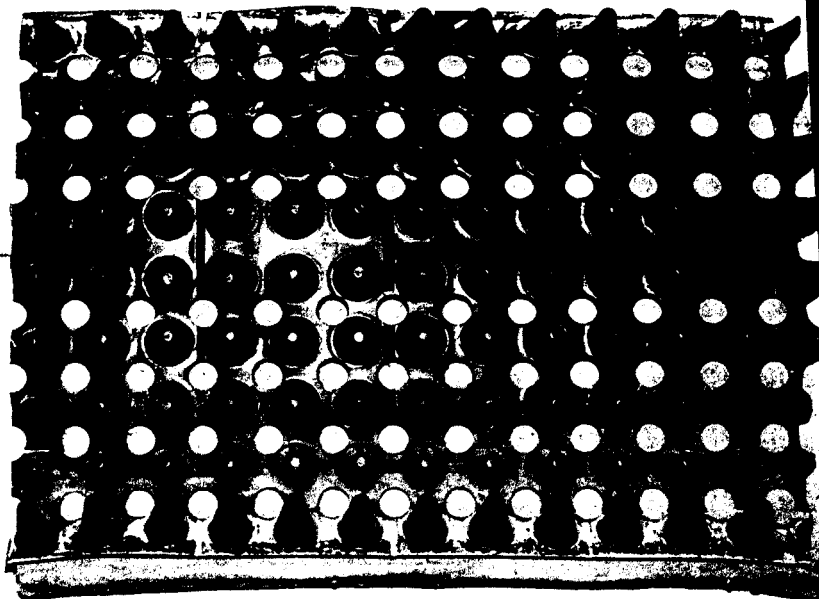
84384
T-2
6-13-95

The core of Contech's Stripdrain consists of conical sections protruding from a flat backing with circular openings. Stripdrain was found to be very brittle and both samples contained cracking. One sample (Contract 84384 T-2) had been bent considerably in the field and was nearly broken into four sections (see Figure 18). The structural performance of Stripdrain was deemed unacceptable.

Figure 18. Highly distressed Stripdrain core.
